**Re: Grand Valley Medical & Dental Centre
Follow-up Structural Review
Project No.: 300057760.0001**

A building condition assessment of the Grand Valley Medical & Dental Centre located at 21 Main Street North in Grand Valley, Ontario was recently completed following a series of flooding incidents in the basement of the existing building. This assessment recommended additional structural review of existing cracks in the concrete block masonry foundation walls and of the retaining walls around the south and east sides of the property. R.J. Burnside & Associates Limited (Burnside) was retained to complete this follow-up structural review.

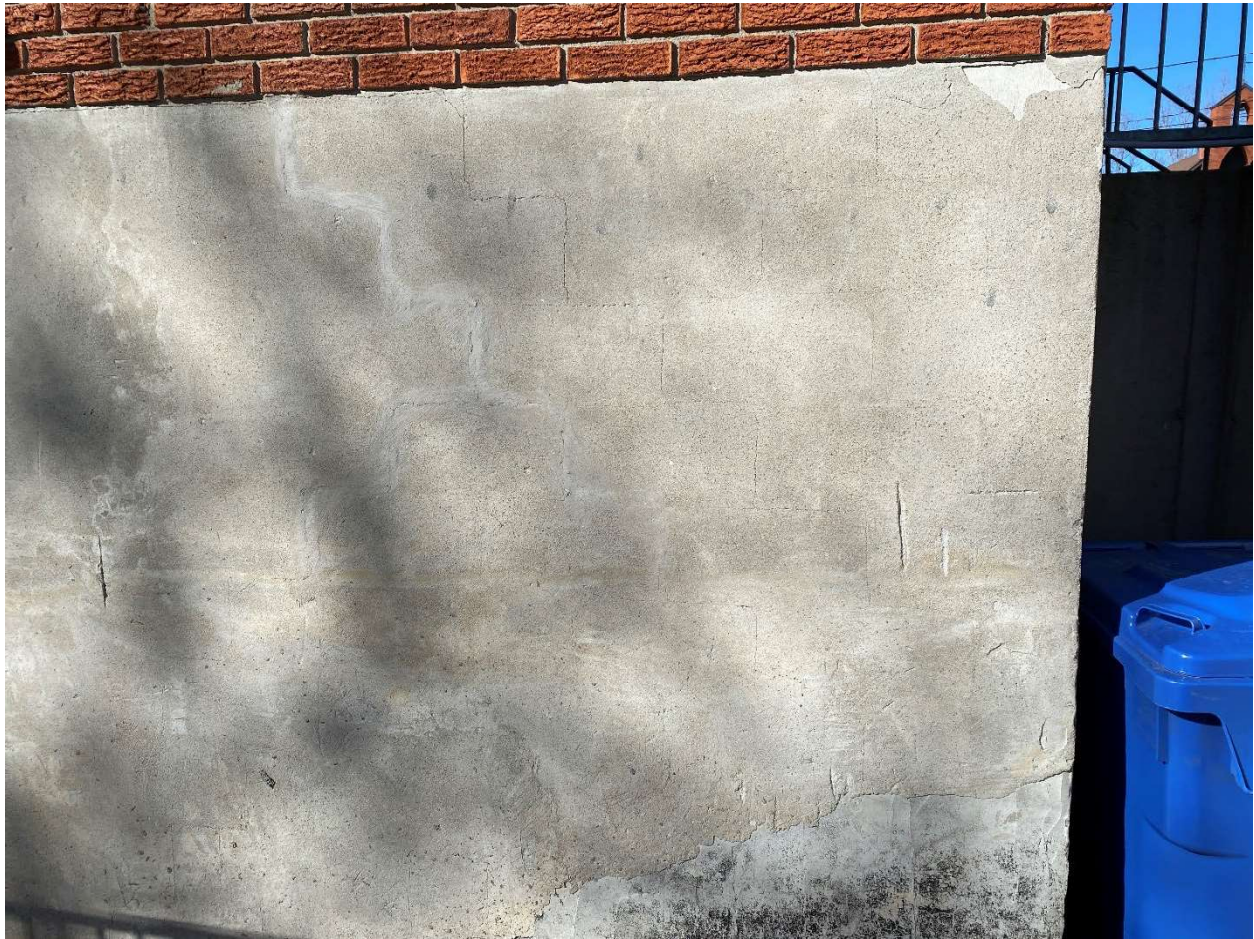
- There are step cracks near the north end of the east foundation wall which follow the mortar joints of the masonry (See Photo 1). These cracks are also visible on the interior of the wall above the stair landing (See Photo 2). The exterior face of the wall is aligned across the cracks. It appears that the exterior parging was repaired and the cracks have reappeared through the repairs.

Photo 1: Step Cracks Near North End of East Foundation Wall

- It is our opinion that the observed issues with the concrete block masonry foundation walls do not indicate an immediate risk of structural failure.
- Based on our observations, the cause of the cracks is unclear. Our observations indicate minimal differential movement across the cracks. We recommend implementing a documented monitoring program to monitor the cracks for further movement. If no further movement is observed, appropriate repairs can be specified. If further movement is observed, additional investigation may be required to identify the underlying cause.
- We recommend directing the downspout and sump pump outlet away from the foundation.

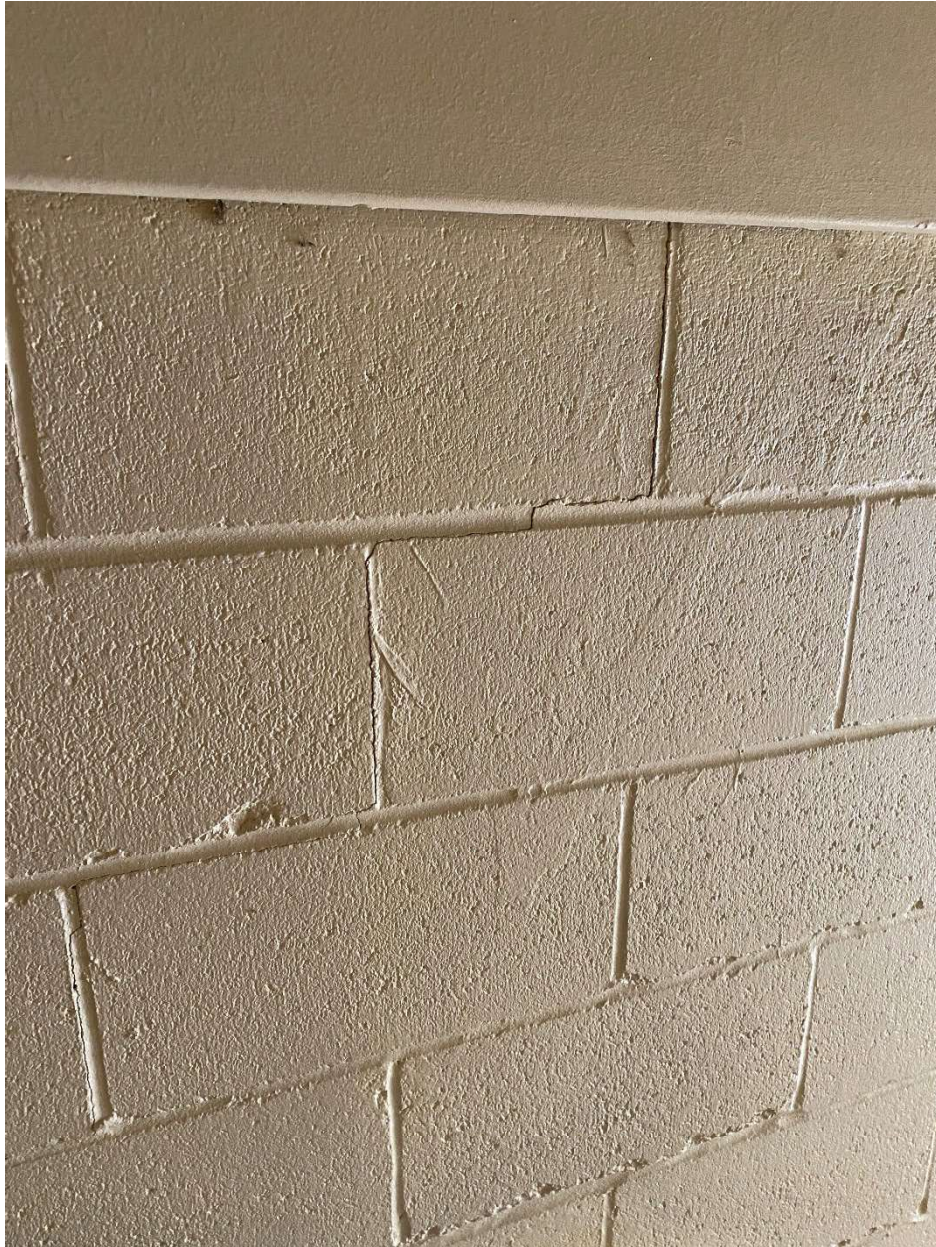
Photo 2: Step Cracks Near North End of East Foundation Wall – Interior View

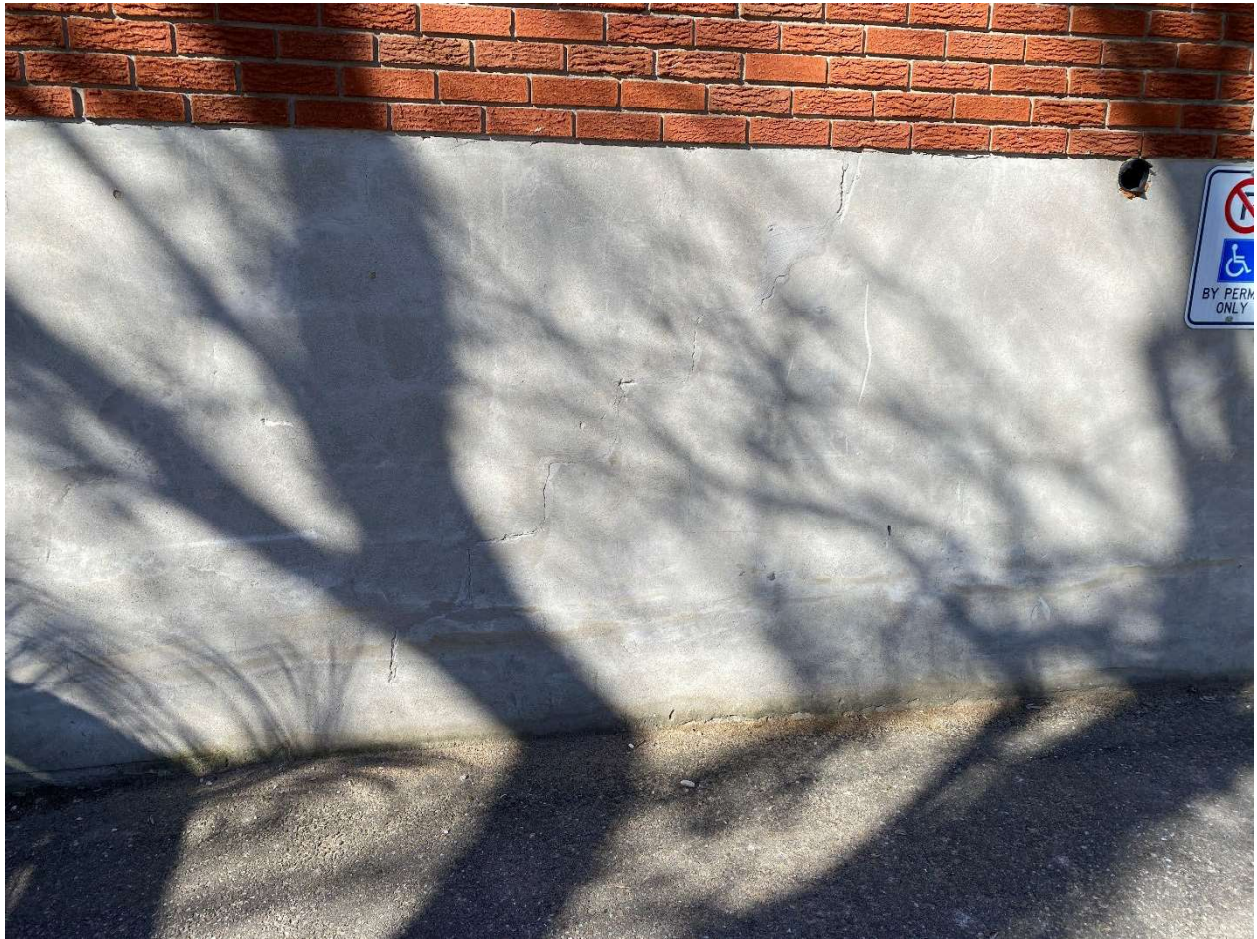
- There are step cracks near the south end of the east foundation wall which follow the mortar joints of the masonry (See Photo 3). The exterior face of the wall is aligned across the cracks. It appears that the exterior parging was repaired and the cracks have reappeared through the repairs.

Photo 3: Step Cracks Near South End of East Foundation Wall

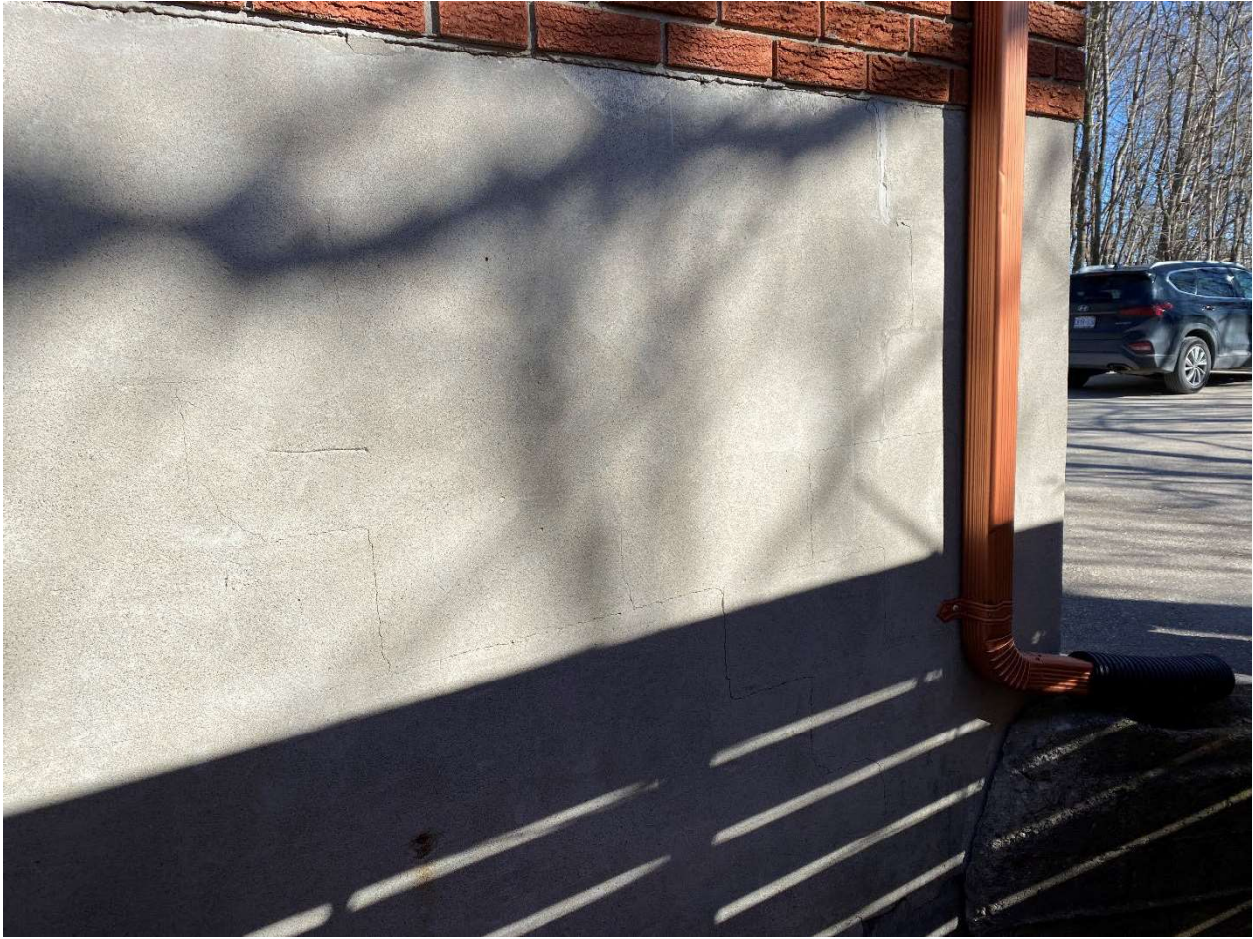
- There is a stepped vertical crack and step cracks near the east end of the south foundation wall (see Photo 4). The stepped vertical crack appears to pass through one masonry unit while the step cracks follow the mortar joints of the masonry. The exterior face of the wall is aligned across the cracks. It appears that the exterior parging was repaired and the cracks have reappeared through the repairs.

Photo 4: Cracks in South Foundation Wall

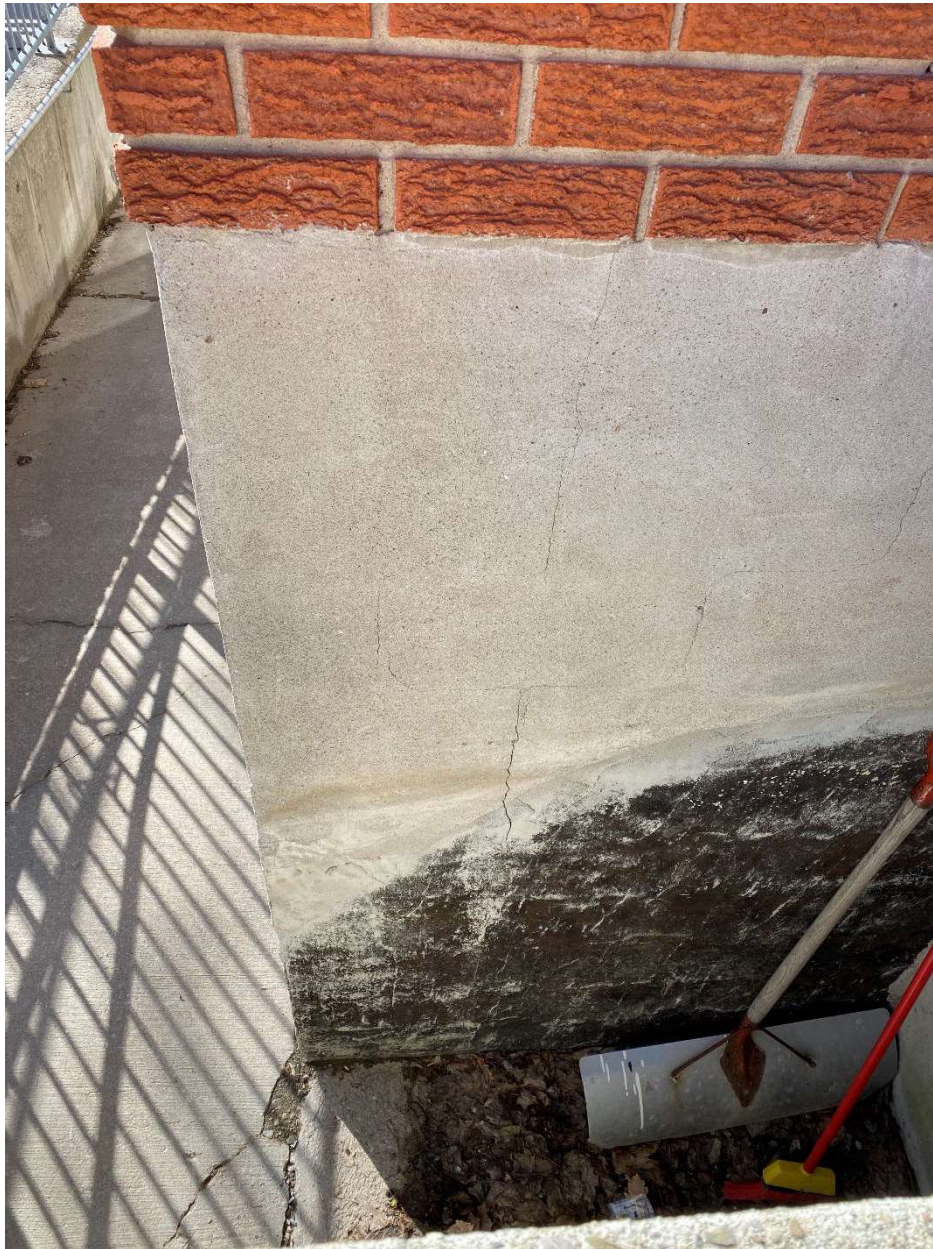
- There is a vertical crack near the west end of the north foundation wall (see Photo 5). The crack appears to pass through several masonry units. The crack appears to extend from the top of the foundation wall to the level of the ramp landing. The width of the crack appears to be uniform over its length. The exterior face of the wall is aligned across the crack.
- The downspout and sump pump outlet at the southwest corner of the building are directed against the south foundation wall (see Photo 6). Adjacent grade along the south side of the building generally slopes down to the east and to the south, away from the building.

Photo 5: Vertical Crack in North Foundation Wall

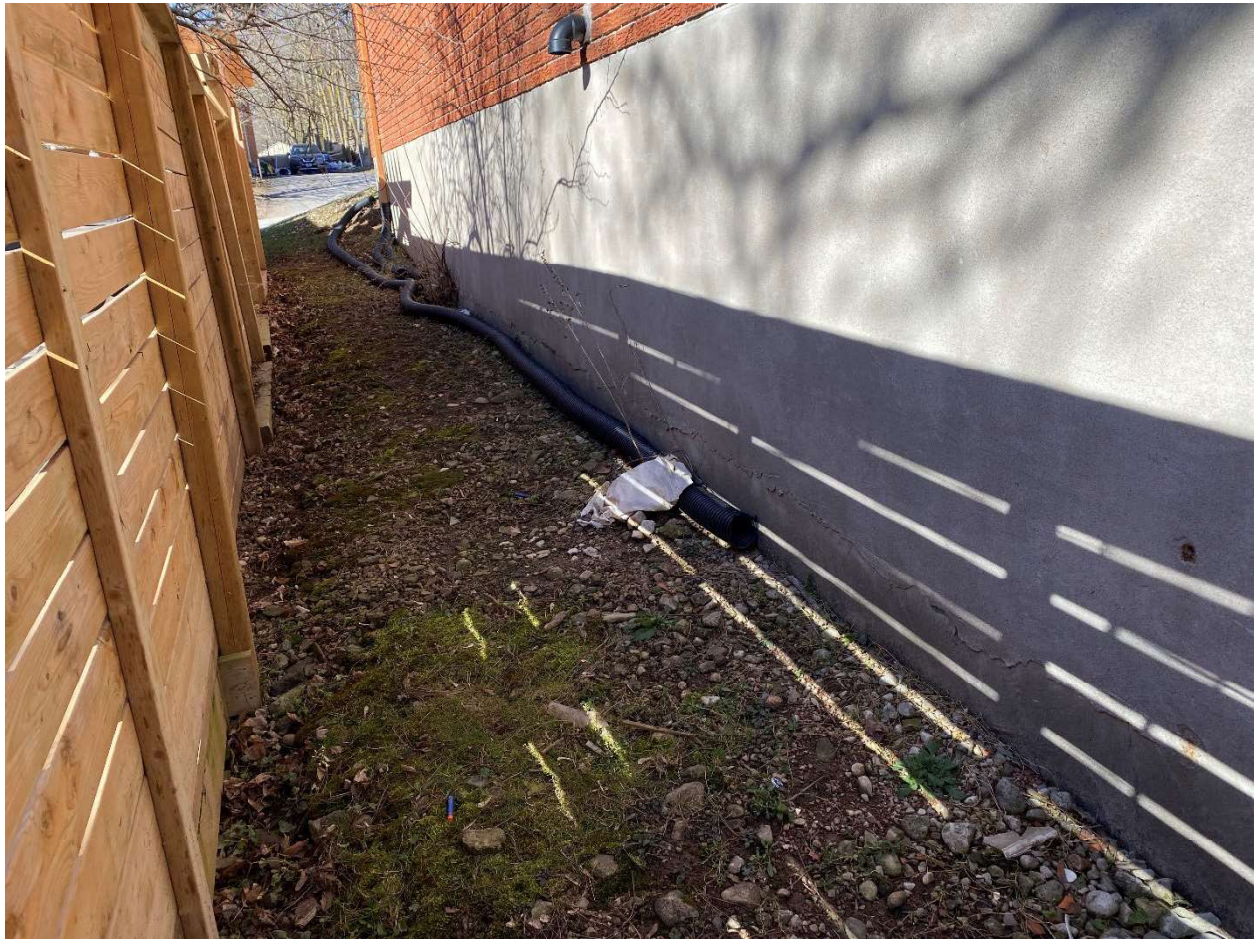
Photo 6: Downspout and Sump Pump Outlet Directed Against South Foundation Wall

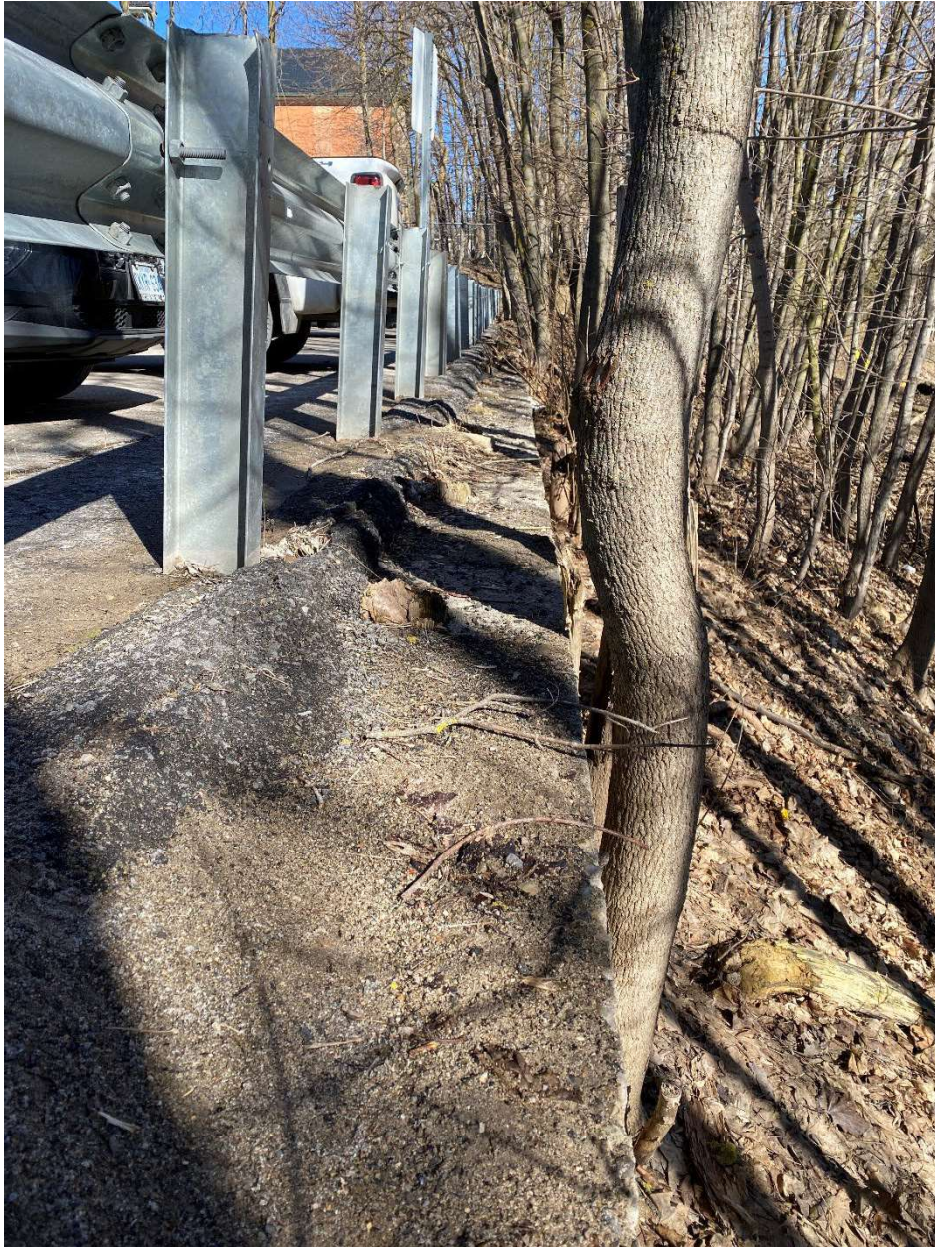
- A steel W-beam guardrail is installed along the south and east sides of the parking lot. The guardrail is supported on wide-flange steel posts driven into the ground adjacent to the high side of the retaining wall (see Photo 7).

Photo 7: Guardrail

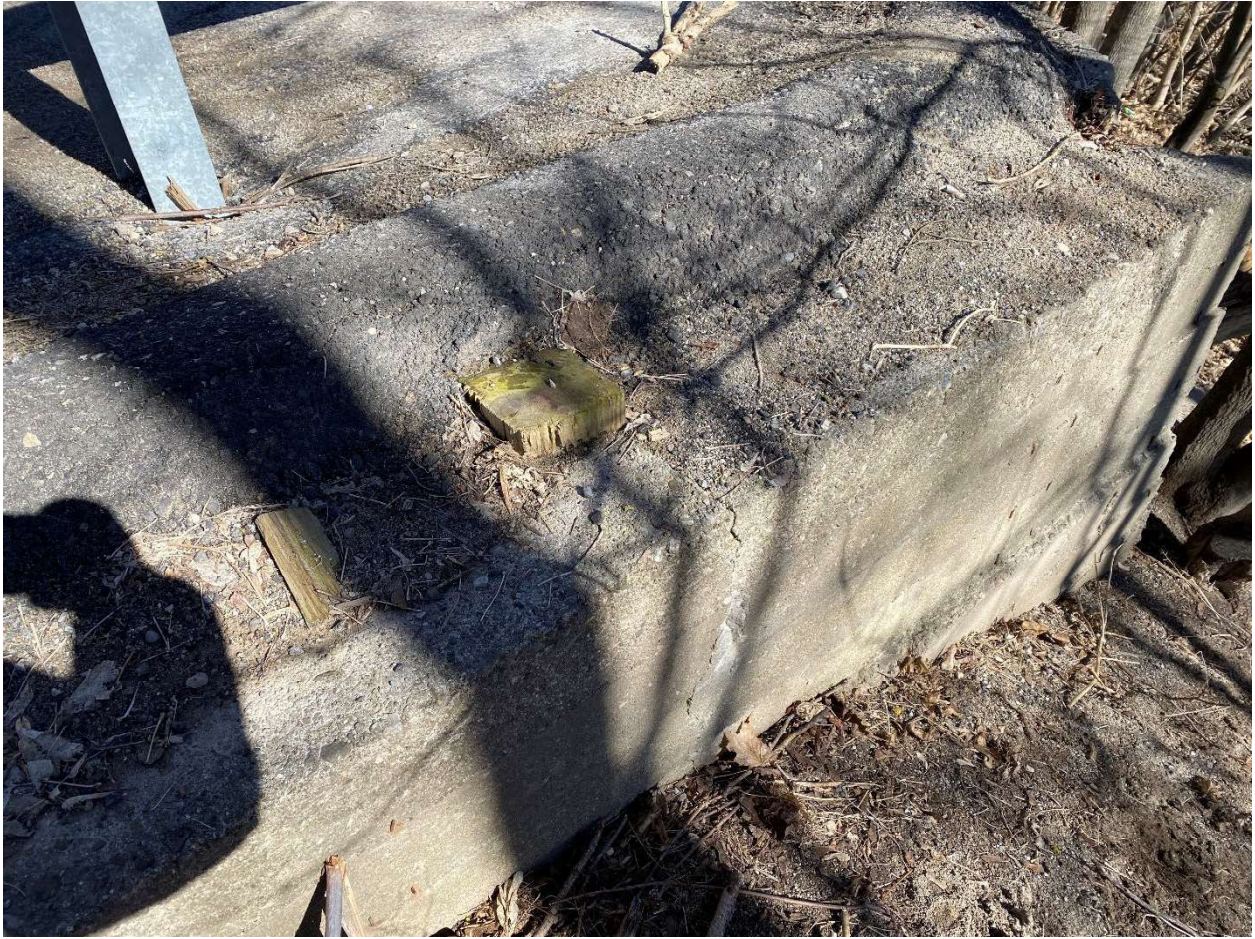
- Stubs from wood posts are cast into the top of the retaining wall at regular intervals. It appears likely that these posts supported a guardrail at one time but have since been cut-off flush with the top of the wall (see Photo 8).

Photo 8: Wood Post Stub

- Based on our observations, the cast-in wood post stubs appear to be causing vertical cracks in the retaining wall. We recommend removing the cast-in wood post stubs from the wall, cleaning all debris from the resulting pockets and filling the pockets with self-consolidating non-shrink grout.

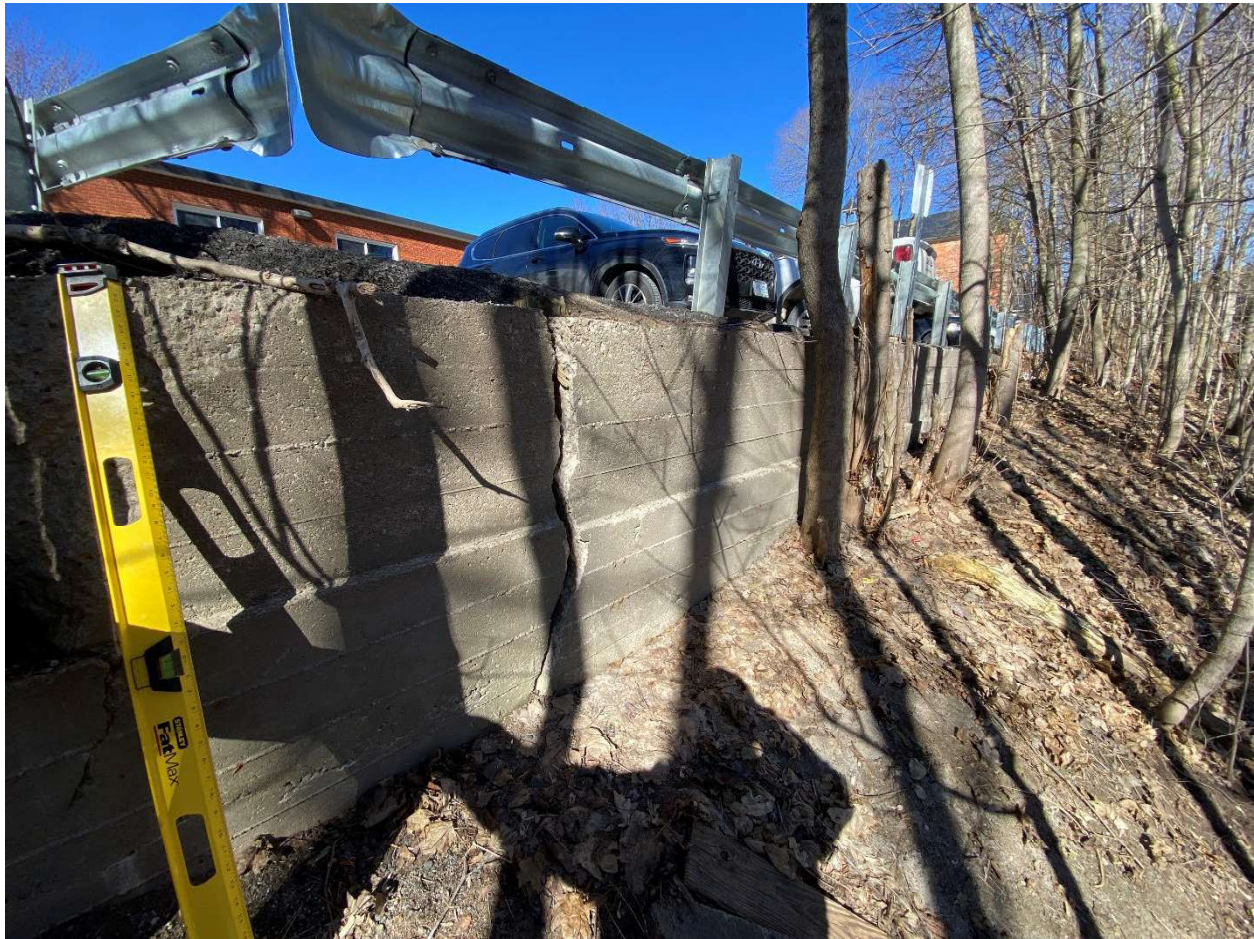
- A vertical crack is present in the retaining wall along the east side of the parking lot, approximately 1.3 m from the southeast corner of the retaining wall. This location aligns with one of the cast-in wood post stubs described above. The crack is approximately 60 mm wide at the top of the wall and approximately 30 mm wide at a point 1.1 m from the top of the wall. The retaining wall to the north of the crack is leaning outward from vertical at an angle of approximately 5 degrees (see Photo 9).

Photo 9: Crack Near Southeast Corner of Retaining Wall

- It is our opinion that the observed issues with the retaining wall do not indicate an immediate risk of structural failure.
- Based on our observations, there has been some movement of the retaining wall. However, it is unknown when and over what length of time this movement occurred. Therefore, we recommend implementing a documented monitoring program to monitor the retaining wall for further movement on a regular basis.

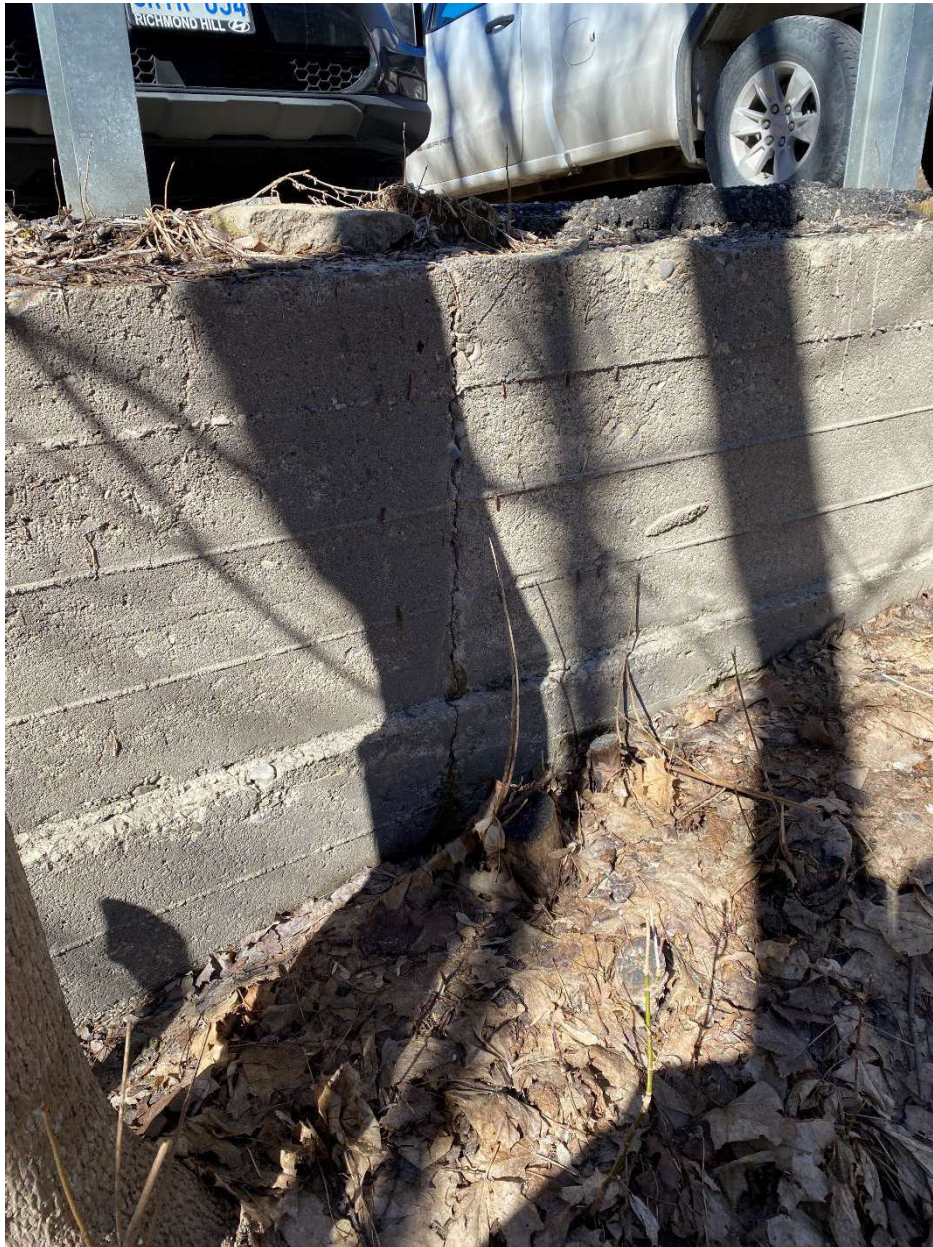
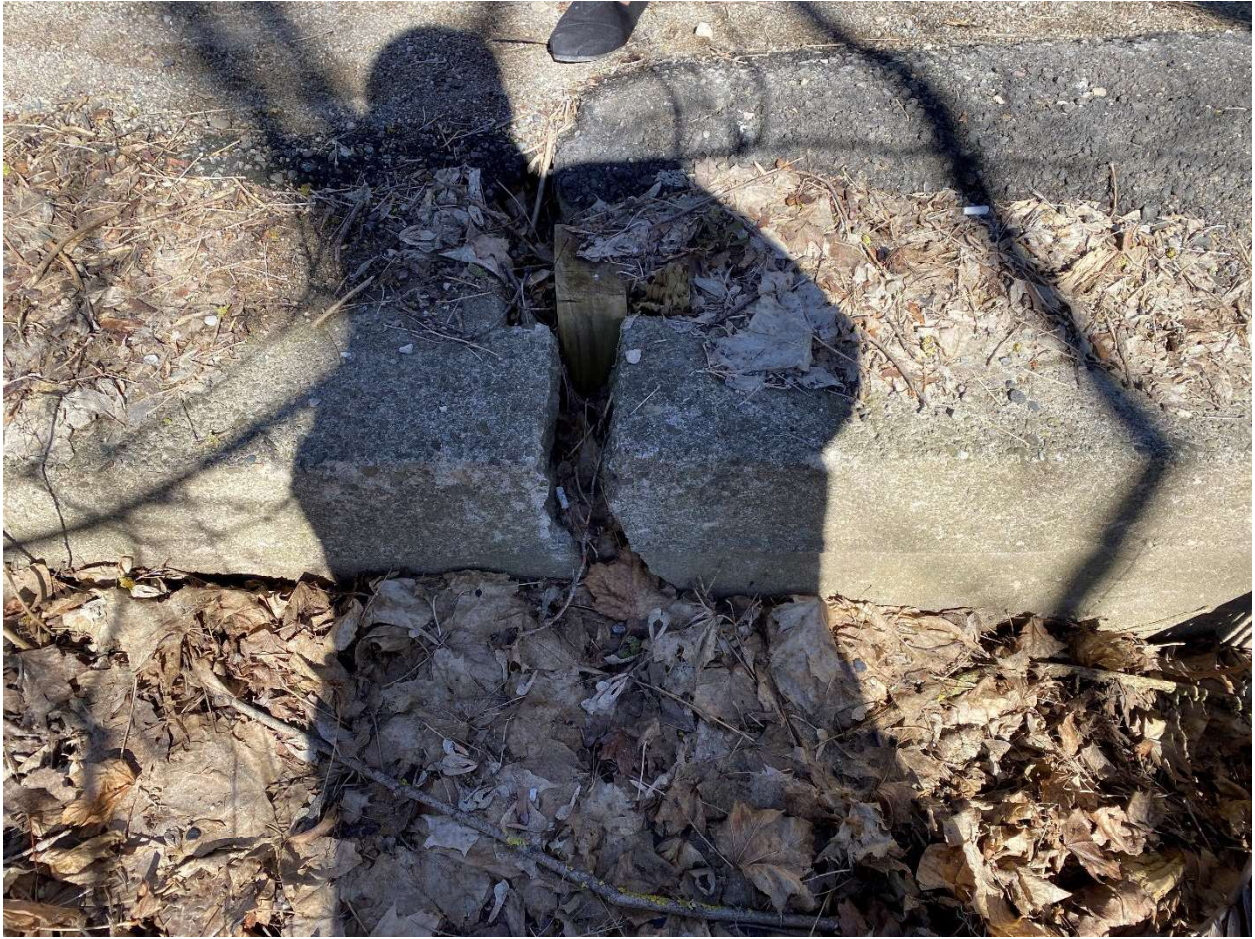
- Additional vertical cracks are present at the locations of other cast-in wood post stubs (see Photo 10 and Photo 11).
- A section of concrete is broken off the southeast corner of the retaining wall. The missing section of concrete matches the height of the cast-in wood post stub at this location and extends from the outside face of the wall to the cast-in wood post stub (see Photo 12).

Photo 10: Vertical Crack in Retaining Wall at Wood Post Stub

Photo 11: Vertical Crack in Retaining Wall at Wood Post Stub

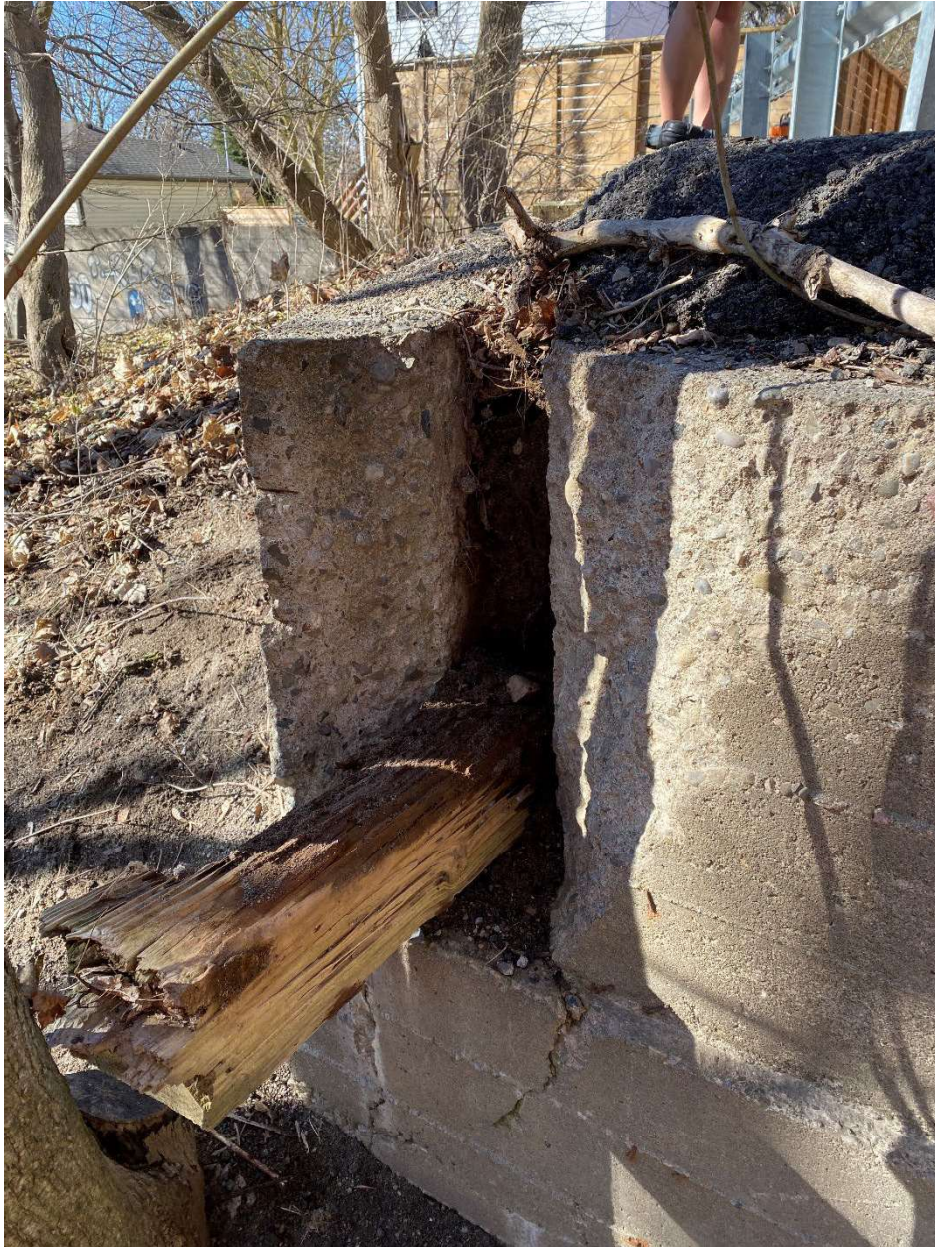
- No reinforcement was observed at the vertical cracks or at the missing section of concrete.

Photo 12: Missing Section of Concrete at Southeast Corner of Retaining Wall

- We recommend repairing the missing section of concrete at the southeast corner of the retaining wall as follows:
 - Remove the cast-in wood post stub and remove all debris;

- Cut the edges of the damaged area square and remove all feathered edges;
 - Roughen all surfaces to a minimum amplitude of 5 mm;
 - Apply bonding agent to all surfaces; and

- Form and place concrete.
